July, 2017 News etter

Horseshoe Draw Ready for Monsoons

Horseshoe Draw Watershed Monitoring Plan

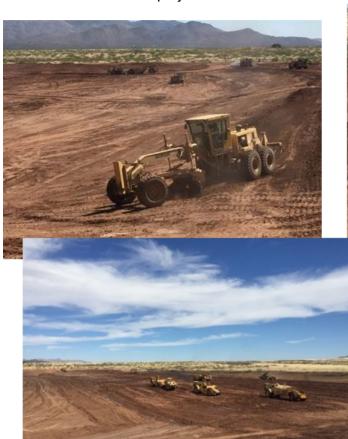
Beginning construction.

Granite crews continued operations. The cut to fill operation started April 3rd and continued throughout the month. Crews were running multiple scrapers, dozers, motor graders and compaction pieces in order to properly build the proposed grades. As crews focused moving the mass amounts of material, the spillway grades as well as corrugated metal pipe (CMP) grades were built. By month end, crews were nearing completion with the cut to fill operation placing over 190,000 cubic yards of dirt. Quality control testing took place on a daily basis to ensure embankment compaction requirements were met. John Ladd and Cochise County personnel continued to oversee and monitor the project.

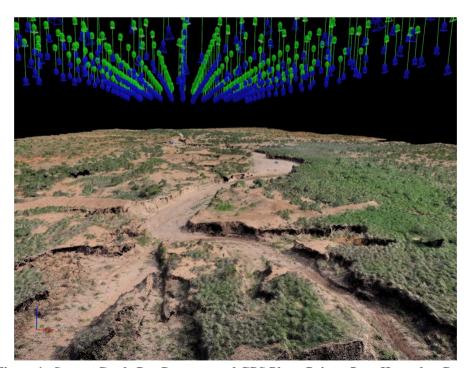
Figure 1. Survey Grade Pre-Programmed GPS Photo Points, Over Horseshoe Draw

- a. Field measurements collected by the survey grade UAV will include overlapping true color photographs that can be processed into a 3D digital terrain model. The high-resolution aerial imagery will provide enough detail to identify and monitor stream channel geomorphology. Survey grade subcentimeter ground control targets placed throughout the drainage will facilitate repeatable data and allow change detection to plus or minus 2 inches within major visible portions of the stream channel.

- c. Aerial targets and an accurate survey control network have been created to assure repeatability of data and ability to detect change over time.

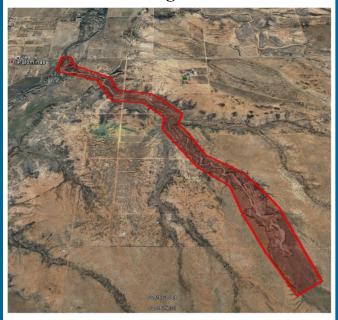
Figure 2. Horseshoe Draw Monitoring Area

The data will be collected for the area shown below. This analysis area includes the control structure location, the headwaters of the watershed and downstream to the confluence with the Upper San Pedro River.

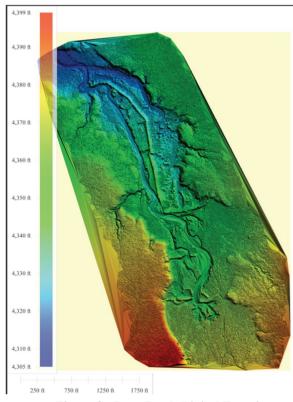
Figure 3. Bare Earth Digital Terrain Model of Horseshoe Draw

Digital elevation models and analytical mapping software (Leica Cyclone, Polyworks and AutoCAD) derived from stereo imagery produced by the aerial photogrammetry will be used to monitor the changing sediment patterns after each flight.
